# The Putra Heights Gas Explosion: An "Accident" or "Incident"? – A Technical and Legal Perspective

The Putra Heights Gas Explosion: A Technical and Legal Perspective

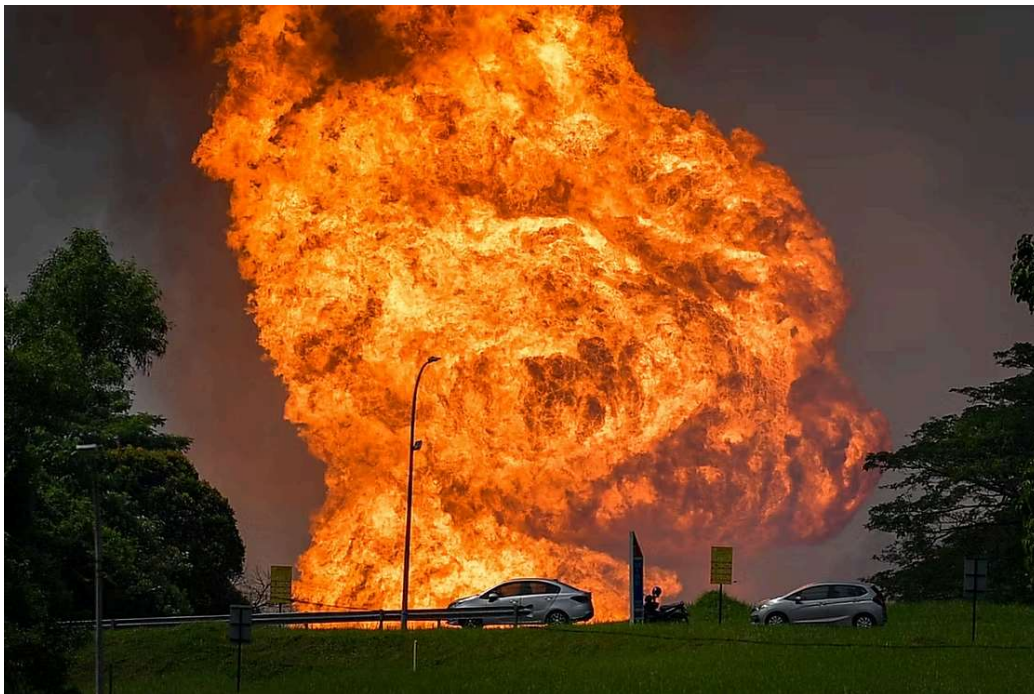
Putra Heights Inferno (Credit: BERNAMA)

On April 1, 2025, a catastrophic gas explosion struck Putra Heights, Subang Jaya in Selangor, Malaysia, with flames reportedly reaching 30 meters high, injuring up to 145 individuals, including three children. The incident, allegedly linked to a significant gas pipeline network in the region, damaged 237 homes and 365 vehicles, displacing over 500 residents.
